# DER ANTIKE SUDAN

HEFT 26 • 2015

CLAUDIA NÄSER

## SITE MANAGEMENT AT MUSAWWARAT ES-SUFRA 2014/15: CONCEPTS, MEASURES AND PERSPECTIVES

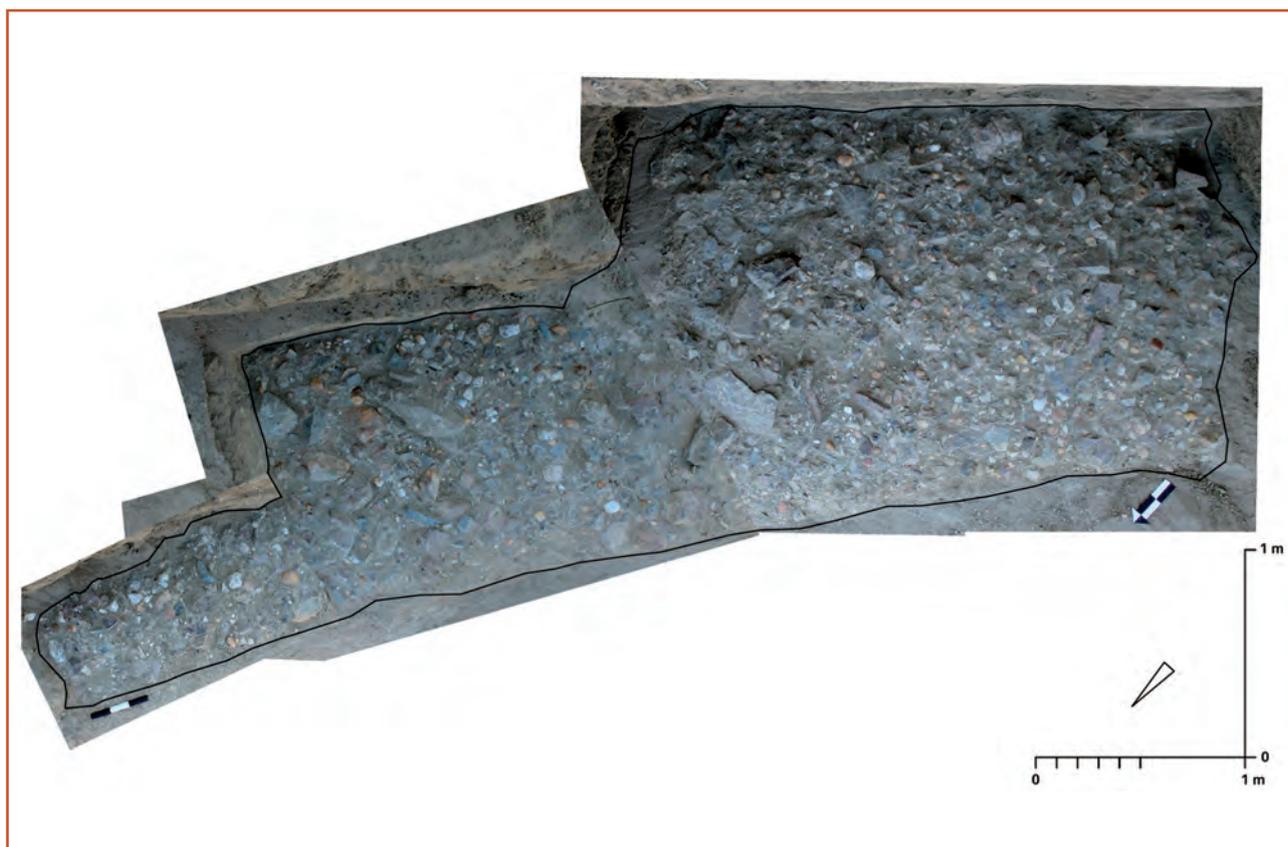
Colour fig. 1: MOG116, Planum 1. Orthophotographical record (lower row, left) and CAD based tracing of different artefact/ecofact classes (field recording: H. M. Alkhidir Ahmed, M. Ehlert; mapping: K. Geßner, A. Dittrich)

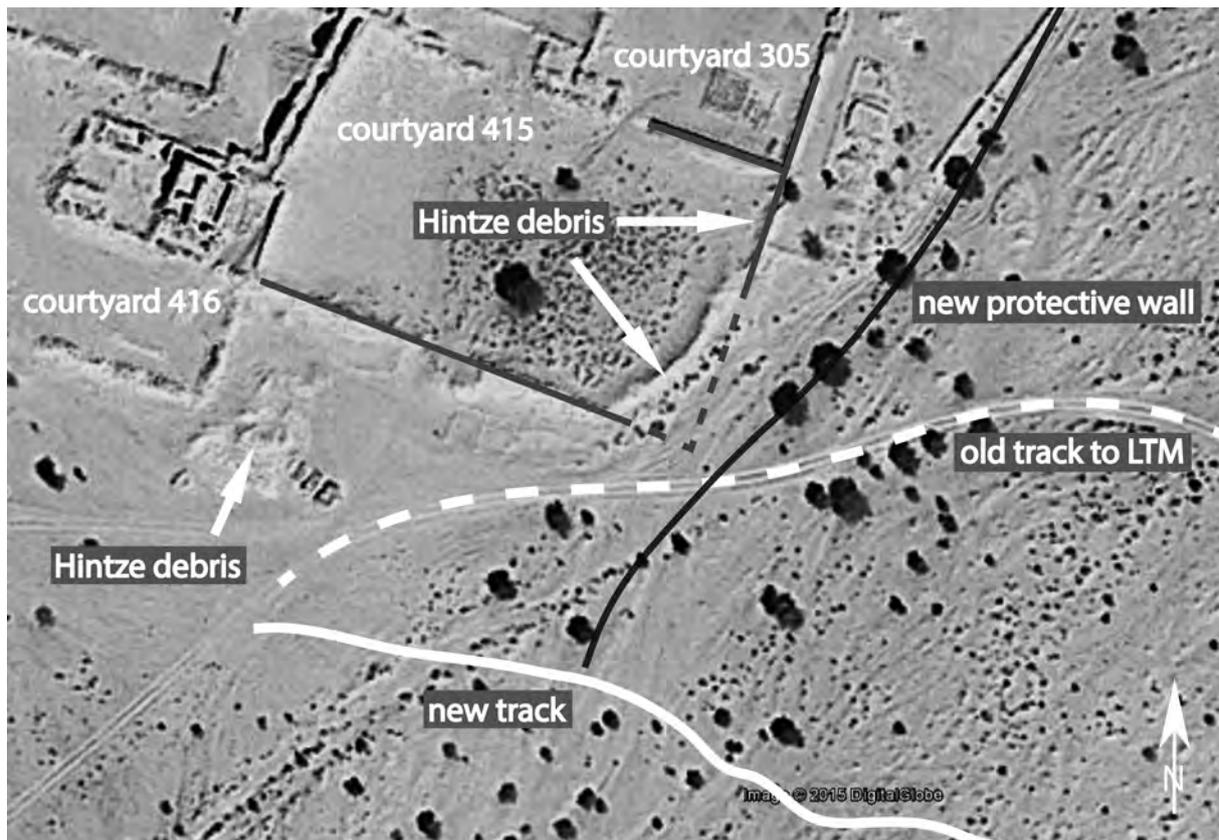
Fig. 1: Schematic representation of site management measures undertaken in the course of redesigning the area southeast of the Great Enclosure (image: Christiane Dorstewitz)

excavation rubble stretching from the preserved corners of walls 415/E and 415/S, thus forming an arbitrary border of courtyard 415 (figs. 1, 7). Visually dominating, this embankment conveyed the feeling that it outlined the original courtyard wall despite the fact that it ran up to 20m west of it.

removal of another *kom* of 1960s excavation debris in the western part of the current parking lot (fig. 1). More than 150m<sup>3</sup> of sand and rubble were moved to enlarge the platform and the protective wall at the edge of the wadi. On top, stone debris from this *kom* was used to build the diversion wall east of the Lion Temple (see previous section). The clearing of the *kom* was not merely an aesthetic measure, but a necessary intervention to prepare the area for the construction of the fence around the Great Enclosure, envisaged for the upcoming project year 2015/16,<sup>17</sup> as the *kom* had obscured the projected course of the fence at the southeastern corner of the adjacent courtyard 416 (figs. 1, 8, 15). The partly collapsed stone repositories in this area (fig. 1) were reconstructed *in situ*.<sup>18</sup>

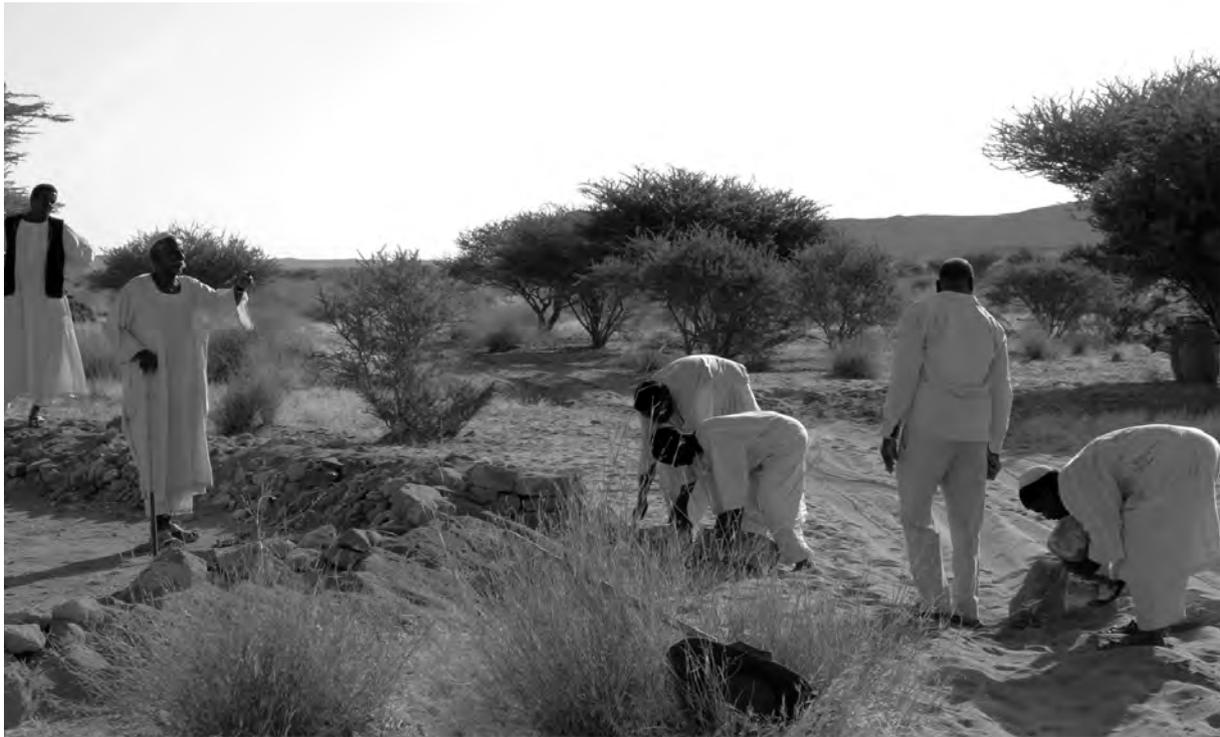
Fig. 2: Blocking the old track towards the Lion Temple under the supervision of Sheikh Mohamed Ahmed al-Dali, in the left part of the image (photo: Claudia Näser)

The first measure of the autumn season 2014 was to relocate the track from the Great Enclosure to the Lion Temple as part of the effort to reorganise the access to the main monuments of the site (figs. 1–2). This measure freed a considerable space at the southeastern corner of the Great Enclosure where the redesign of the main entrance towards the monument is to unfold. The old route to the Lion Temple was blocked and the proposed new route further south prospected so as to make sure that no hitherto unknown archaeological sites would be compromised. After these preparatory measures, the new route was prepared and levelled by manual

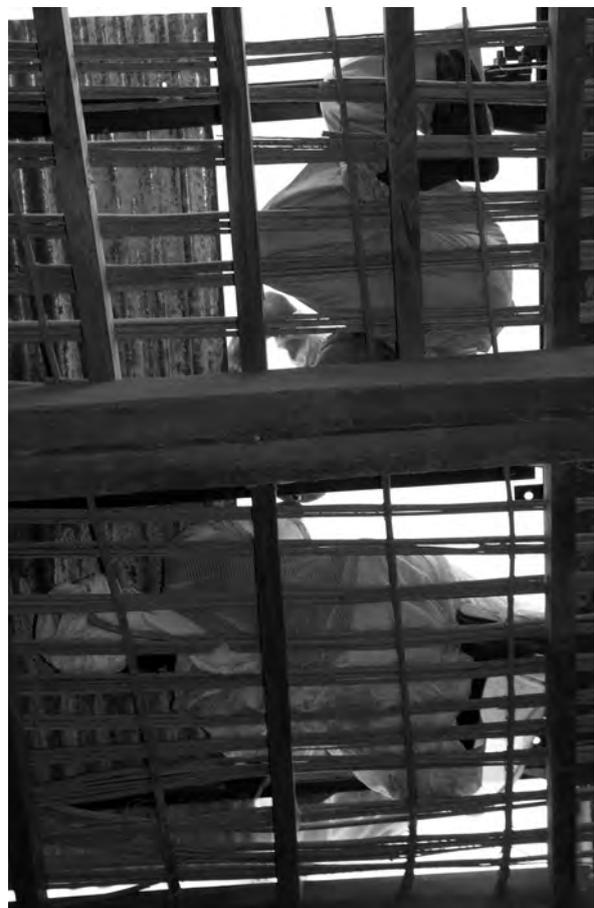
Fig. 3: Preparing the roof of the Lion Temple for investigation, October 2014 (photo: Claudia Näser)

week visit to the site by the major project participants in October 2014. The purpose of this visit was to assess the condition of the individual parts of the original roof construction to confirm on-site which parts would need to be replaced due to wear or redesigned due to malfunctions of the original construction, to collect final data for the static calculations and to assess which materials would be needed for the actual building measures. In terms of practical measures, this step included the temporary removal of parts of the roofing sheets and the suspended ceiling of *birsh* mats (fig. 3) in order to ease the investigation of the construction from underneath.

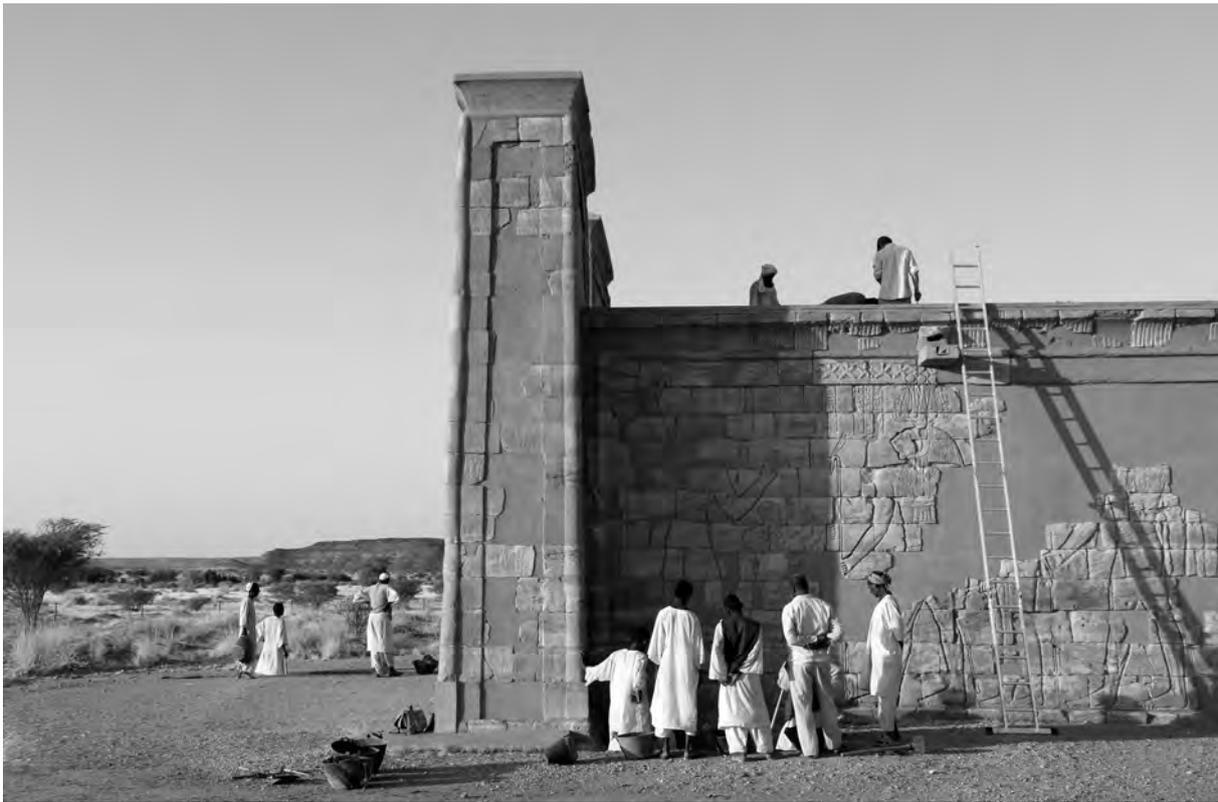
Fig. 4: Excavations at the southern and northern pylon towers of the Lion Temple, October 2014 (photo: Claudia Näser)

The comprehensive investigation of the potential causes of these cracks was continued with excavations in the area of the temple's two pylon towers (figs. 4–5).<sup>10</sup> The findings showed that the cracks had not been caused primarily by the inadequate roof bearings – although they negatively impacted them –, but by an accelerated dehydration of the mighty unreinforced concrete body which underlies the reinforced concrete foundations of the temple proper (fig. 5). This dehydration had prevented the proper setting of the concrete body, resulting in an increased porosity of its outer shell, which then led to a localised settlement of the standing walls in the pylon area and the cracks between the front and the rear part of the temple. The investigation also showed that while the cracks do not impair the static of the building or any of its parts in any way, they cannot be effectively removed as they continue into the lowest part of the tripartite foundation construction, namely the unreinforced concrete body. As an aesthetically adequate handling, the insertion of deliberate expansion joints has been suggested and will be implemented within the upcoming project dedicated to the conservation of the temple's relief walls and the re-plastering of its reconstructed wall sections.

<sup>10</sup> Southern pylon tower: front, towards east; northern pylon tower: rear, towards northwest.

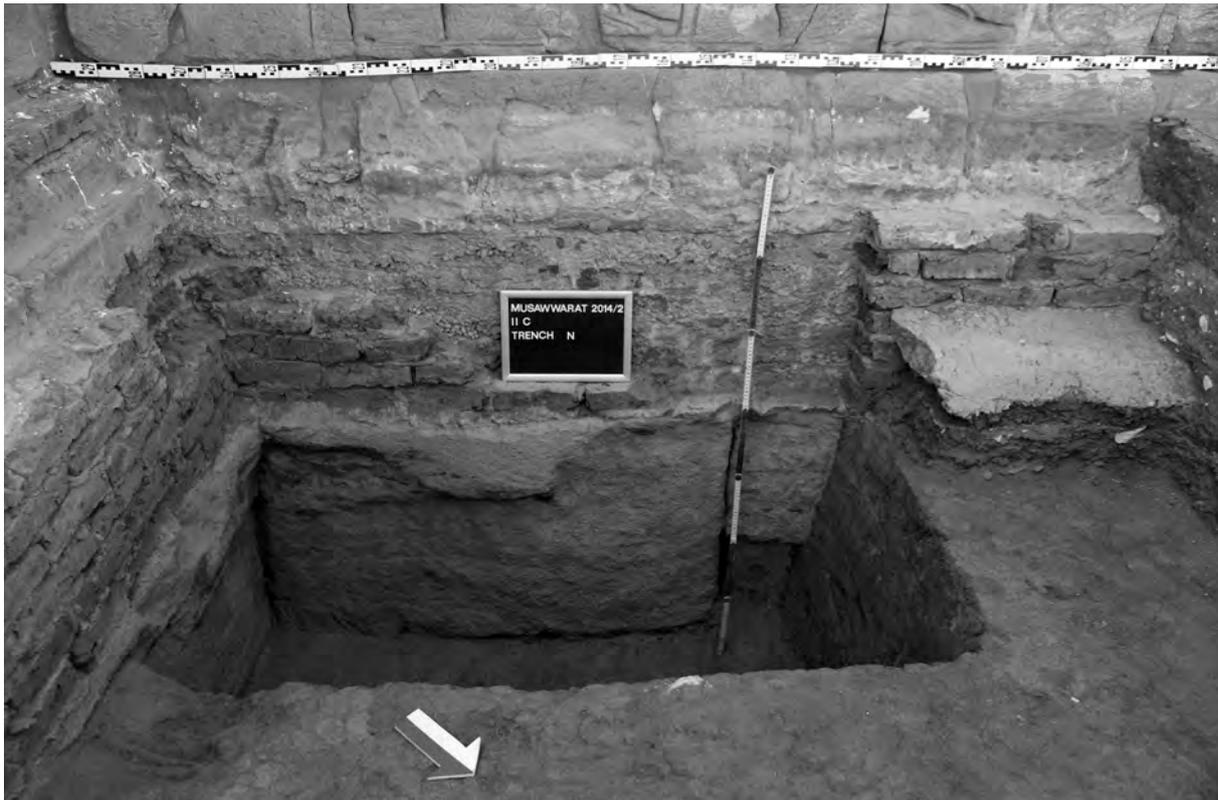
Fig. 5: The foundations of the reconstructed Lion Temple consisting of a mighty unreinforced concrete body underneath the actual reinforced concrete foundations, the brick-lining of which has been supported by a concrete 'shirt' (preserved on the right side), exposed in the trench in the rear of the northern pylon tower (photo: Claudia Näser)

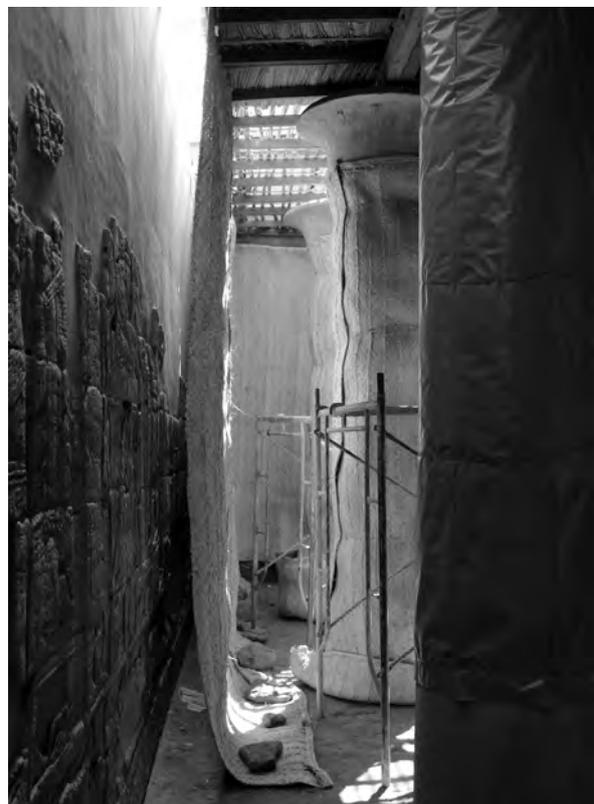
Fig. 6: The interior of the Lion Temple during the building measures, January 2015 (photo: Claudia Näser)

duced and stabilised with a pebble cover. Preparation of the manually pre-fabricated imported roofing materials was completed on-site by the project's two tinsmiths. The installation of the main roof of corrugated zinc-plated steel sheets was complemented with additional elements, namely the polycarbonate translucent sheets of the light strips as well as the zinc-plated steel gutters, the covers of the gargoyles and the attica between the two pylon towers. Finally two new crack monitors were installed at the interior lateral walls.<sup>11</sup> The project was successfully completed on 16 March 2015.

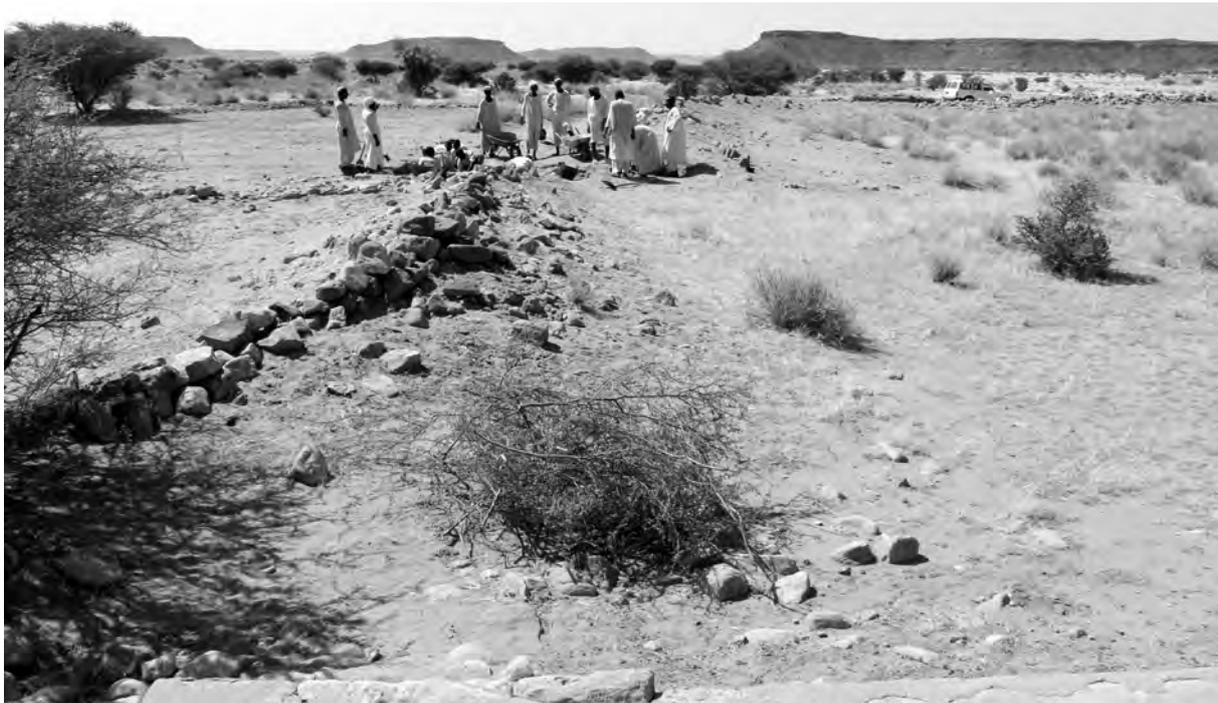
Fig. 7: The embankment of excavation debris delineating courtyard 415 towards southeast (photo: Claudia Näser)

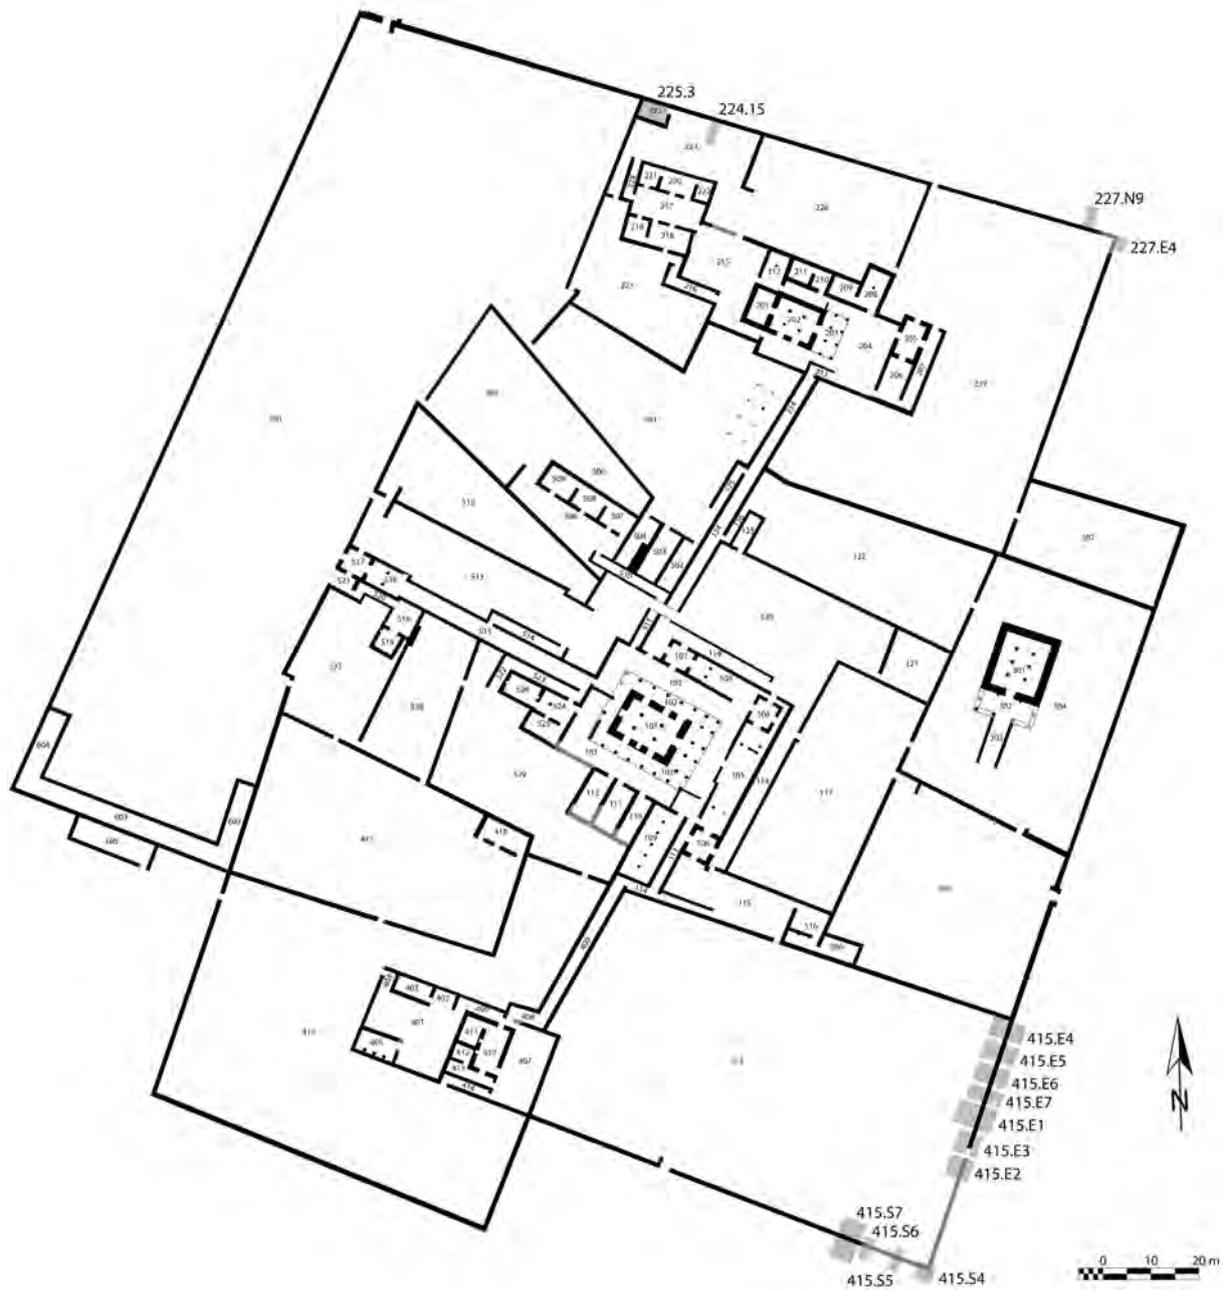
Fig. 8: Ground plan of the Great Enclosure with excavation areas of the current project year 2014/15 indicated (adapted from P-IA/11, cartographic and graphic realisation: Christiane Dorstewitz)

With the new access to the site being planned to eventually use the ancient main entrance to the Great Enclosure (fig. 8: gate 305-E), the visitor route from the parking lot in the south of courtyard 415 will have to follow the eastern border of courtyard 415 towards the north (figs. 1, 8). It was therefore decided to investigate to which degree the ancient courtyard wall, which also represents the outer enclosure wall of the monument in this area, was really lost, or could still be traced at least in foundations – which would outline the original course of the wall and could be incorporated in a low brick reconstruction of the original corner.

Excavations of six trenches along the 70m of lost wall in the east and south of courtyard 415 (fig. 8: 415.E1–3, S4–6) in the fall season 2014 indicated that indeed no substantial remains of wall 415/S were left beyond where it is still preserved above ground to the present day. In contrast, the foundation layer of wall 415/E could still be traced up to 20m south of corner 415/305/E (fig. 8). An unexpected discovery was a hitherto unknown entrance gate, 415-E, which came to light in trench 415.E3 (figs. 8–9). Only its northern side is preserved in a single foundation layer, the southern part having been swept away completely.

In view of these findings it was decided to enlarge the archaeological investigation of wall 415/E in the spring season 2015 (fig. 8: 415.E4–7, S7) in order to completely uncover the preserved wall section and to evaluate the possibility of its reconstruction in brick masonry to delineate its course above ground. The excavation produced another unexpected result: The northernmost 20m of the Hintze embankment running up against corner 415/305/E (figs. 1, 7–8, 10) contained substantial *in situ* remains of the wall even above the present-day ground surface, which had simply been covered with the excavation debris in

Reconstruction of the outer wall of the Great Enclosure started in 1997. In 1998 its northeastern corner (fig. 8: 227/N+E) was re-erected, and in the following year the rebuilding was continued towards south.<sup>24</sup> Recently, a crack had developed at the inadequately formed joint between the 1998 and 1999 segments (fig. 18), primarily due to the settlement of the 1998 portion. This settlement was in turn provoked by rain water accumulations and fluvial erosion brought about by the uncontrolled outlet of the drainage from the site museum. Two mitigation measures were implemented. First, the drainage of the museum was shifted into a new outlet channel (fig. 19) which runs into a newly built infiltration well north of the enclosure wall (fig. 20). This well has a diameter of 1.8m and a depth of c. 3m, and is filled with brick rubble, covered with a plastic sheet and a layer of earth. After the cause for the settling had thus been remedied, the enclosure wall around the crack was taken down and re-built with a deliberate expansion joint (figs. 19, 21).

Sand dunes which had accumulated at the outer enclosure walls (fig. 8: 224+225+226+227/N, 227/E, 337/N) were removed and the main eastern front of the monument (307+304+305/E) was cleaned. Large heaps of excavation rubble, stones and broken bricks from earlier conservation work, which had been deposited in a working area north of the Great Enclosure, were removed as a first measure

In spring 2015, lime mortar capping concentrated on Complexes 200 and 500 of the Great Enclosure i.e. the buildings and courtyards surrounding Temple 200 and north of the Central Terrace (figs. 8, 22). Altogether, 190m of walls received a cover. Photographs were taken of all walls prior to their treatment in order to facilitate condition assessments and future monitoring.

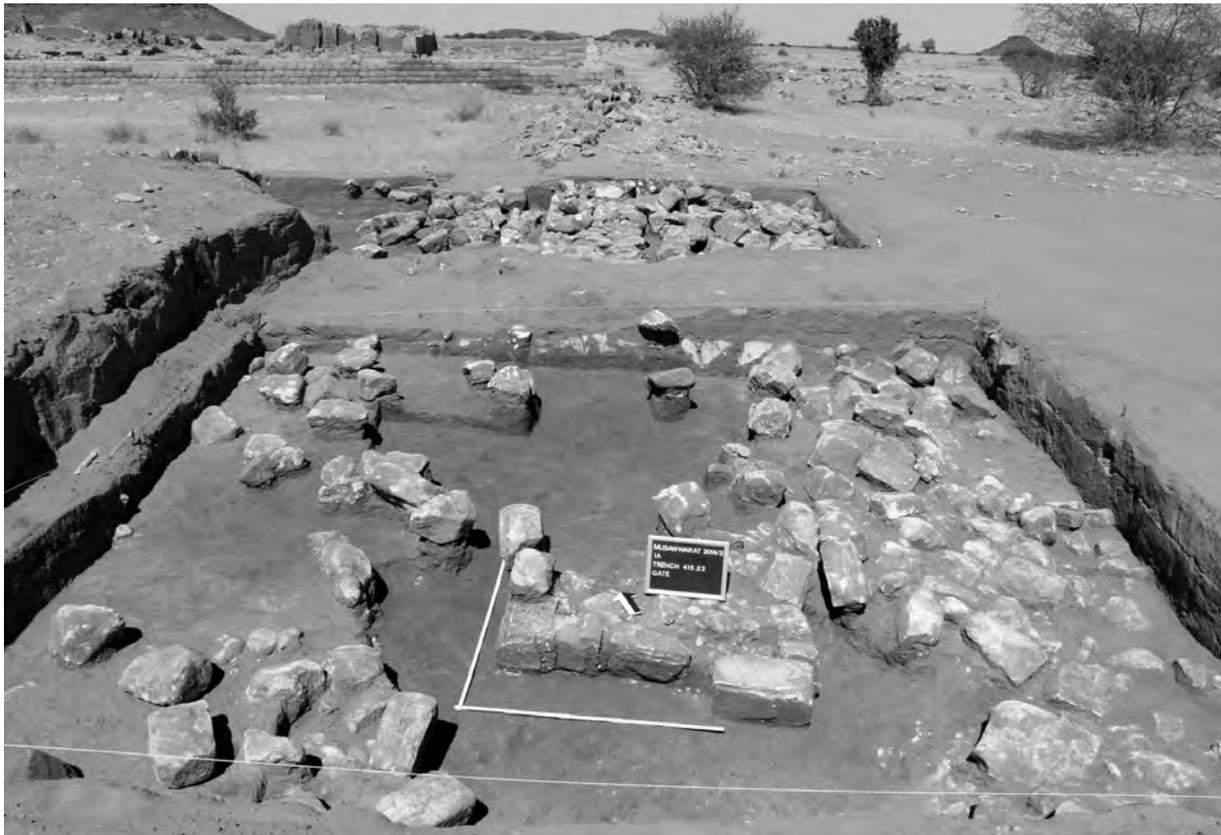
Fig. 9: The newly discovered entrance gate into the Great Enclosure, 415-E, in trench 415.E3 from the south (photo: Claudia Näser)

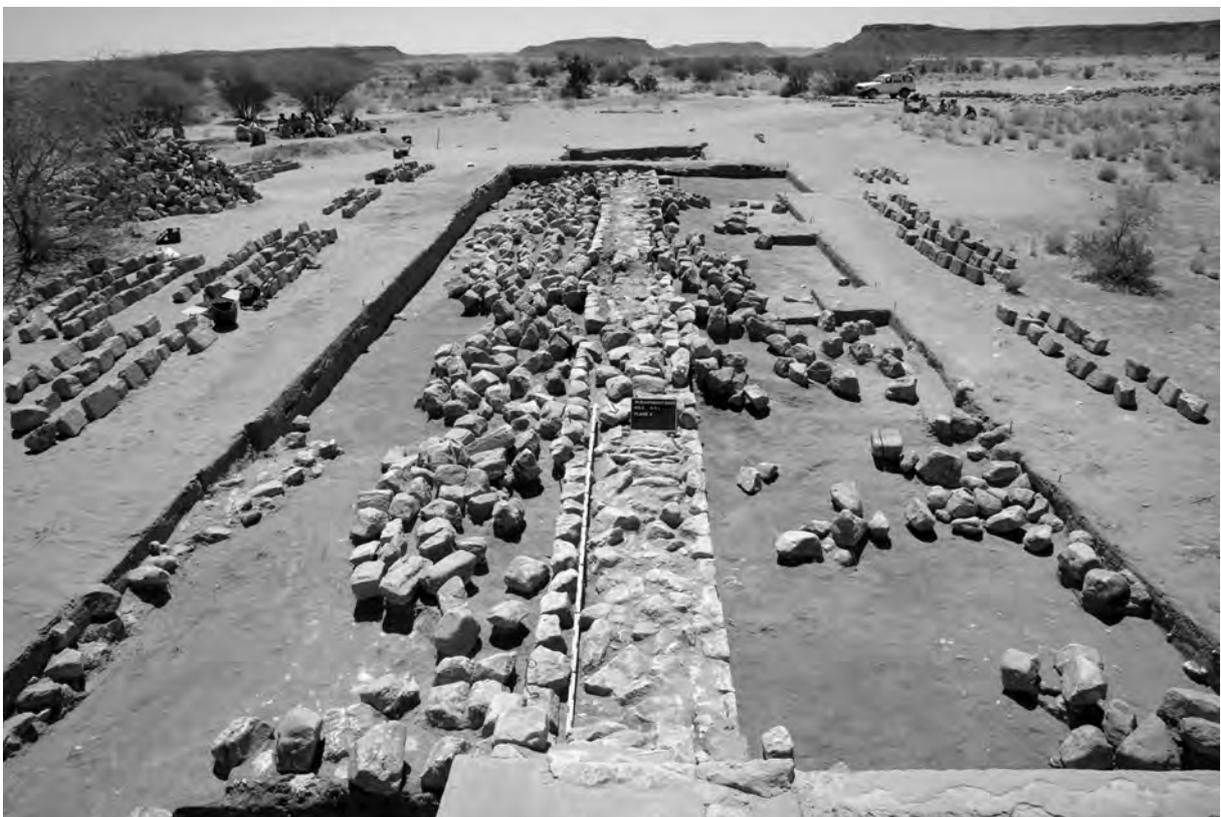
Fig. 10: Trenches 415.E4, 5, 6, 7, 1 (after documentation and removal of bulks) and 415.E3 in the south with the recovered segment of the enclosure wall 415/E (photo: Claudia Näser)

the 1960s. In addition, up to six layers of *en bloc* wall collapse were revealed (figs. 10–11) which had the potential to be reassembled in their original position. With these findings, more than 20m of the ancient enclosure wall and a hitherto unknown entrance gate were regained.

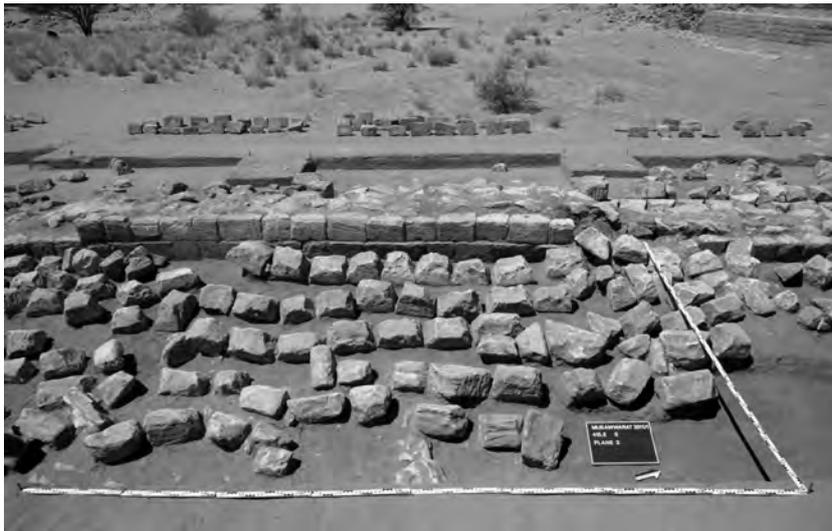
Fig. 11: Trench 415.E6 with up to two layers of the wall 415/E *in situ* and up to six layers of *en bloc* block collapse (photo: Claudia Näser)

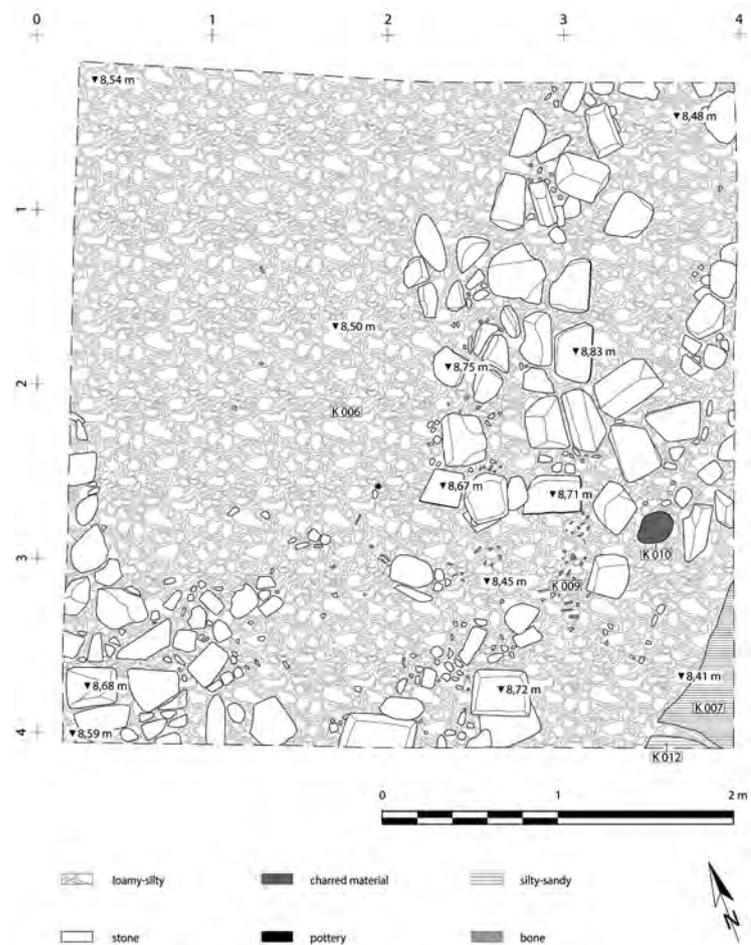
Fig. 12: The lowest layer of wall collapse in Trench 415.S4 with the supposed corner indicated in bold lines (drawing: Claudia Näser)

Finally, the remains of the abovementioned ‘missing’ corner of the enclosure, i.e. the southeastern corner of courtyard 415, were also detected. The reopened trench 415.S4 (fig. 8) produced a substantial layer of wall collapse, starting from the local height of 8.93m, going down up to about 8.5m (fig. 12).

While the stratigraphic record and a considerable spread of blocks towards the south and east, i.e. the direction of the wadi, proved heavy fluvial activities, the trench also revealed a corner situation with an actual corner block almost in alignment with the reconstructed north-south course of wall 415/E (fig. 12).

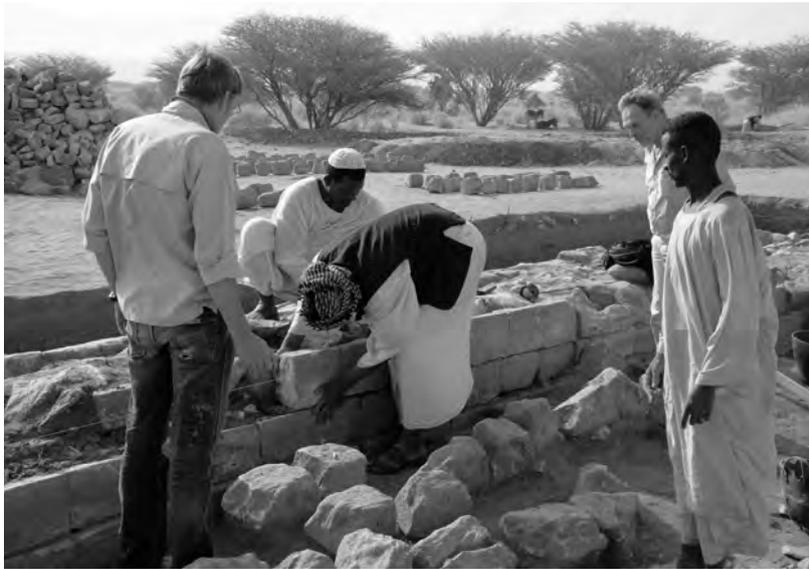
Fig. 13: Reconstruction of wall 415/E (photo: Claudia Näser)

After the excavation had been completed, the reconstruction of wall 415/E started (fig. 13), following the concept established in the previous years.<sup>15</sup> By the end of the season, the wall was reconstructed over a course of almost 20m up to six courses high. The remaining parts will be finished in the upcoming project year.

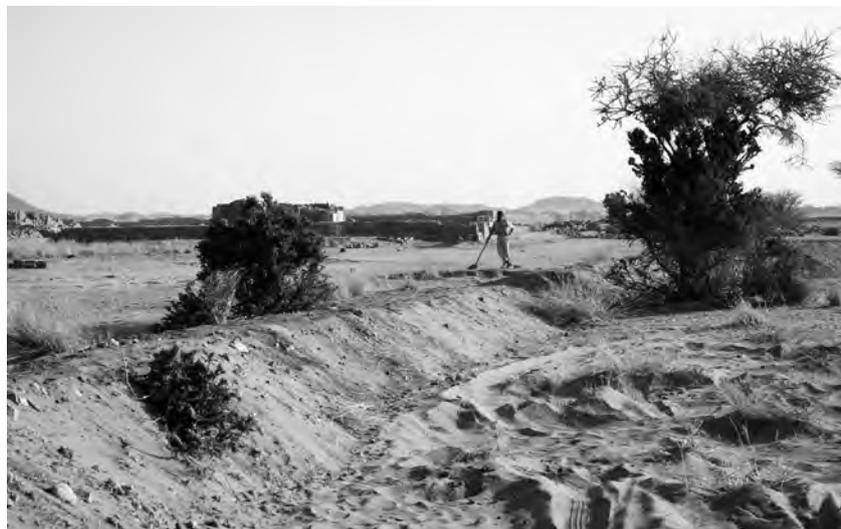
Fig. 14: The southwards extension of the protective wall towards the wadi east of the Great Enclosure (photo: Claudia Näser)

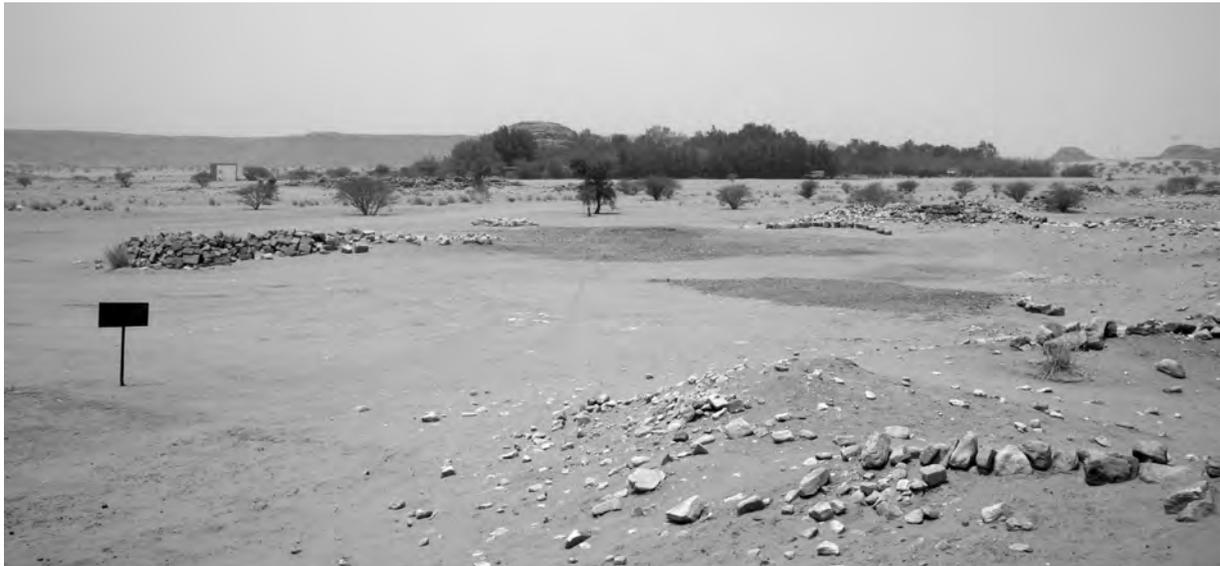
Fig. 15: The customary parking lot south of the Great Enclosure with the area of the cleared *kom* visible as dark patches; the stone repositories to the left were rebuilt later (photo: Claudia Näser)

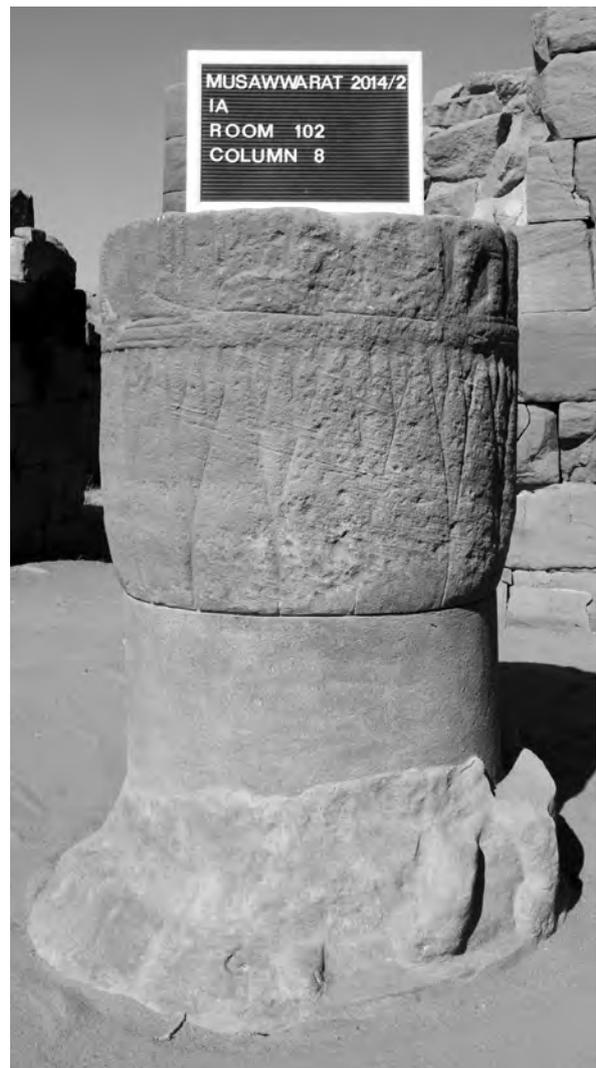
Fig. 16: The lower part of column 8 *in situ* after its conservation (photo: Claudia Näser)

A pilot phase for the conservational project component was launched in spring 2014 and continued in the current project year. In spring 2014 the base of column 8, which was still standing in its original position immediately north of the entrance to the Central Temple, had been treated as a trial piece to test and refine the conservation strategy.<sup>22</sup> In order to protect the piece during the ongoing treatment, it was temporarily removed to the on-site museum. In the autumn season 2014 its conservation was completed, the object was returned to its original position on the terrace and the lowest of the five column drums was successfully installed on top of it (fig. 16).

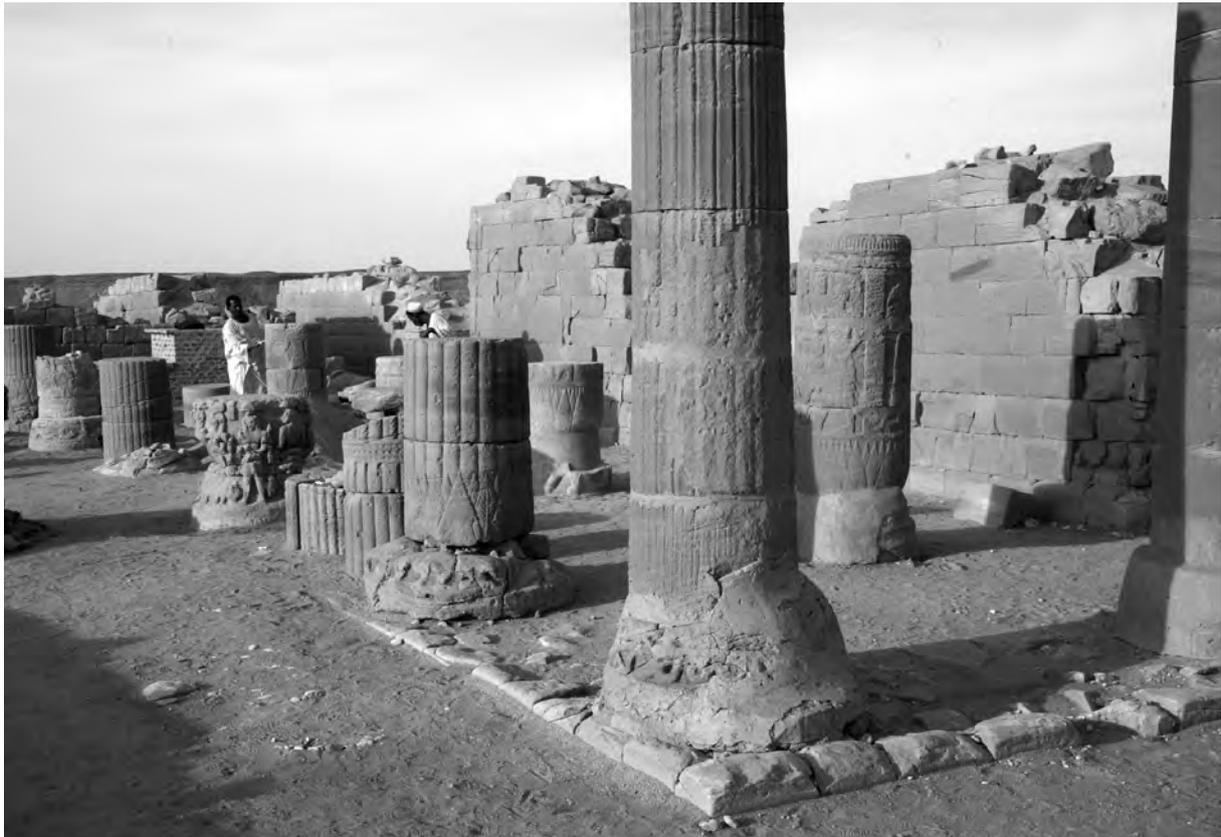
Fig. 17: The columns in front of Temple 100 with their protective encasings temporarily removed during the conservation survey; note the restored column 8 in the rear row (photo: Claudia Näser)

With the insights from column 8, a detailed condition assessment and work schedule for the treatment of the other seven columns, plus two additional columns of the outer peripteros circle, were prepared in the spring season 2015. This survey included an identification and detailed autopsy of all existing column fragments *in situ* (fig. 17), in the on-site museum and in the temporary stone repositories at the site. A detailed report of the findings and the resulting operational programme was drafted, and its implementation will continue with measures to consolidate the stone substance of the columns in autumn 2015. For the time being, all pieces on the Central Terrace, with the exception of the newly conserved parts of column 8, have once again been secured by protective brick encasings.

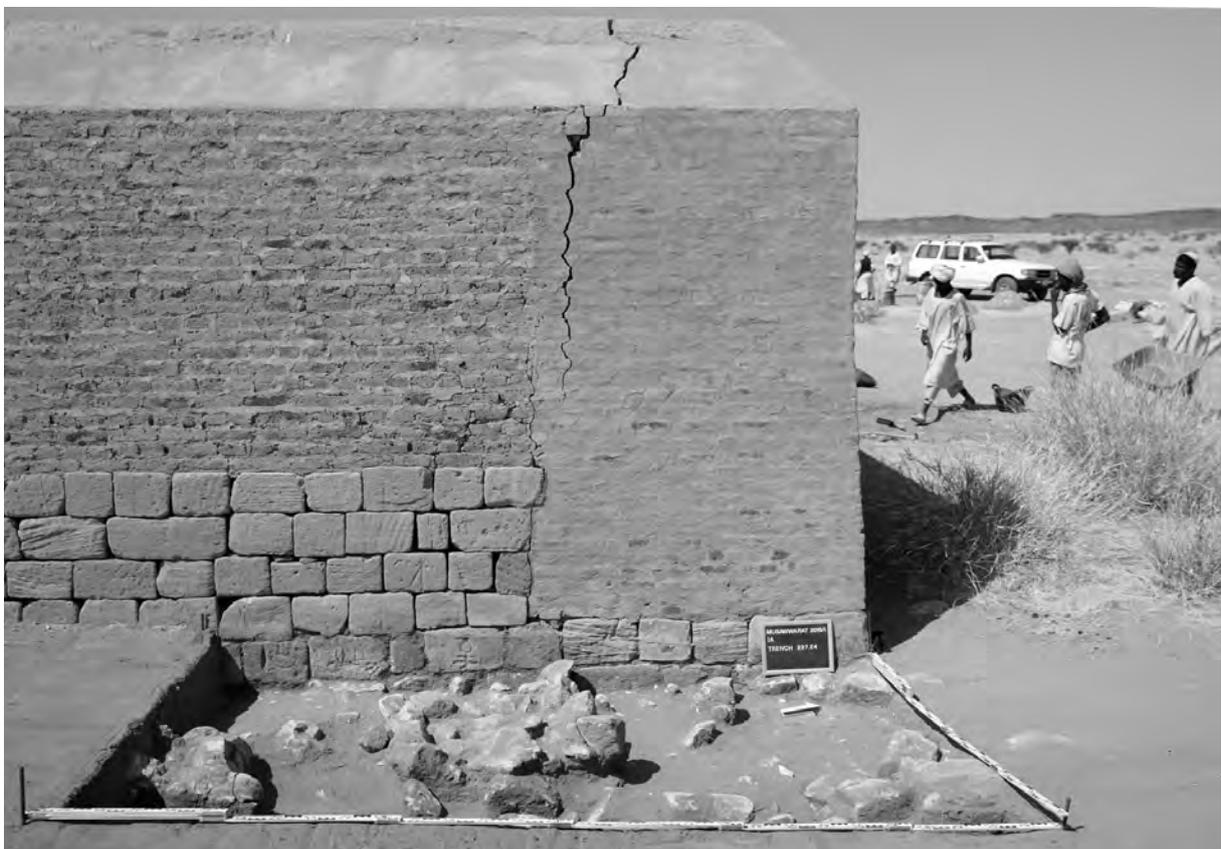
Fig. 18: Crack in the reconstructed enclosure wall at the northeastern corner of the Great Enclosure (photo: Claudia Näser)

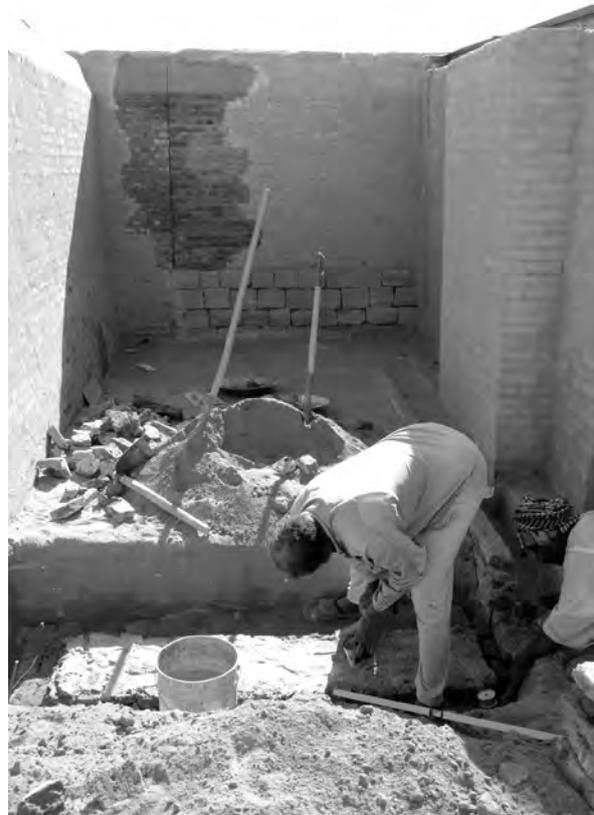
Fig. 19: Construction of the new outlet channel for the drainage of the site museum; note the re-modeled, though still unplastered area of the crack in the enclosure wall in the rear (photo: Claudia Näser)

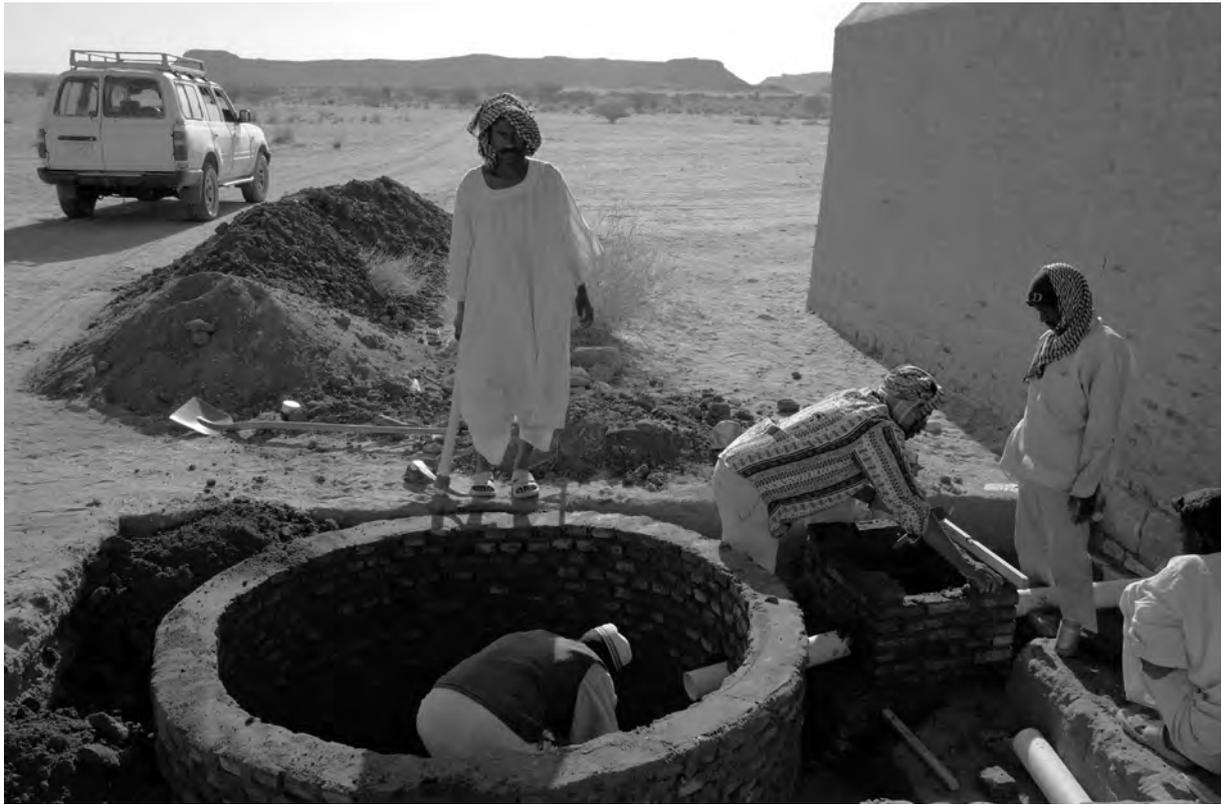
Fig. 20: Construction of the infiltration well outside the enclosure wall (photo: Claudia Näser)

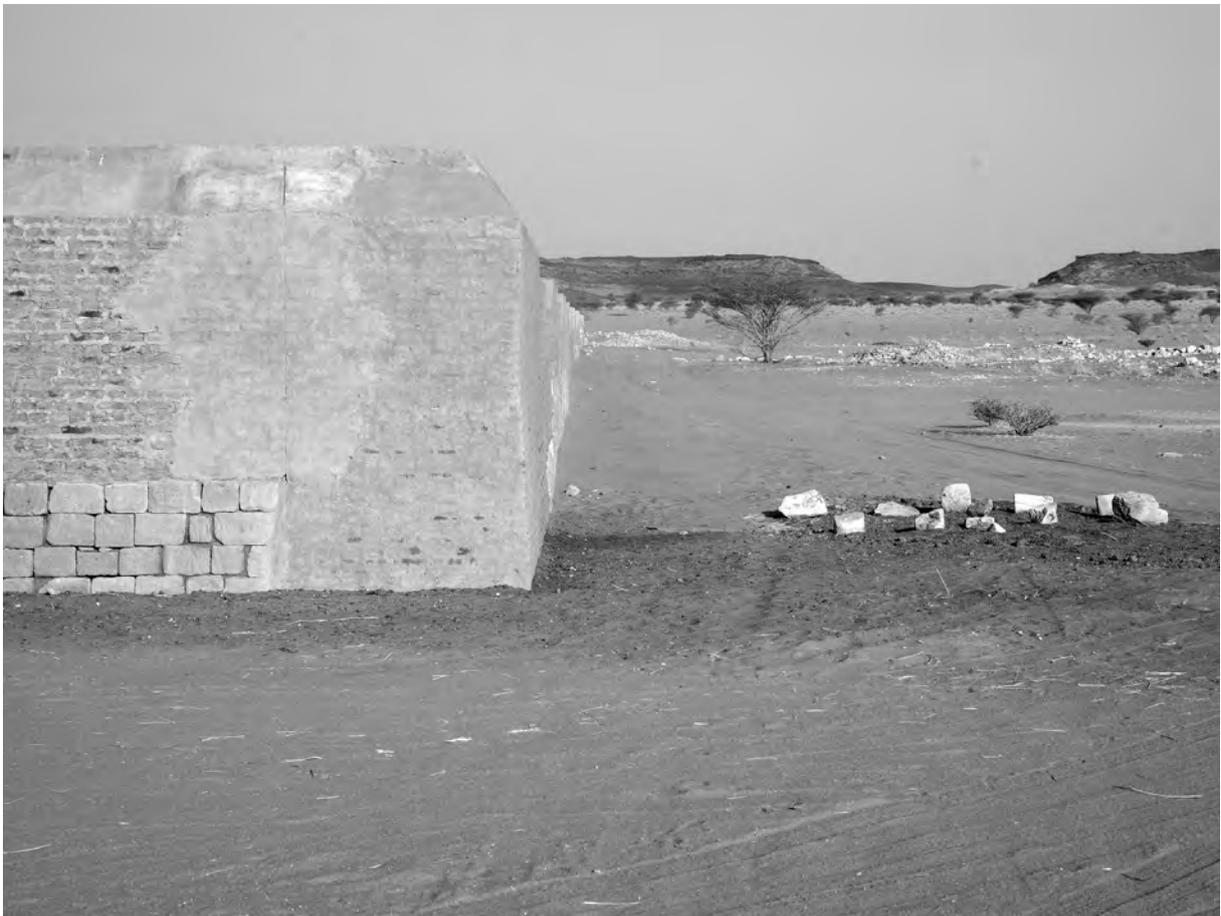
Fig. 21: The northeastern corner of the Great Enclosure after the completion of the measure (photo: Claudia Näser)

in the rehabilitation of this part of the site (fig. 21), which will be continued in connection with the construction of the fence in the coming project year. The material from these clearings was also used in the extension of the platform southeast of the Great Enclosure (cf. above p. 15).
