# DER ANTIKE SUDAN

HEFT 26 • 2015

CLAUDIA NÄSER

## SITE MANAGEMENT AT MUSAWWARAT ES-SUFRA 2014/15: CONCEPTS, MEASURES AND PERSPECTIVES

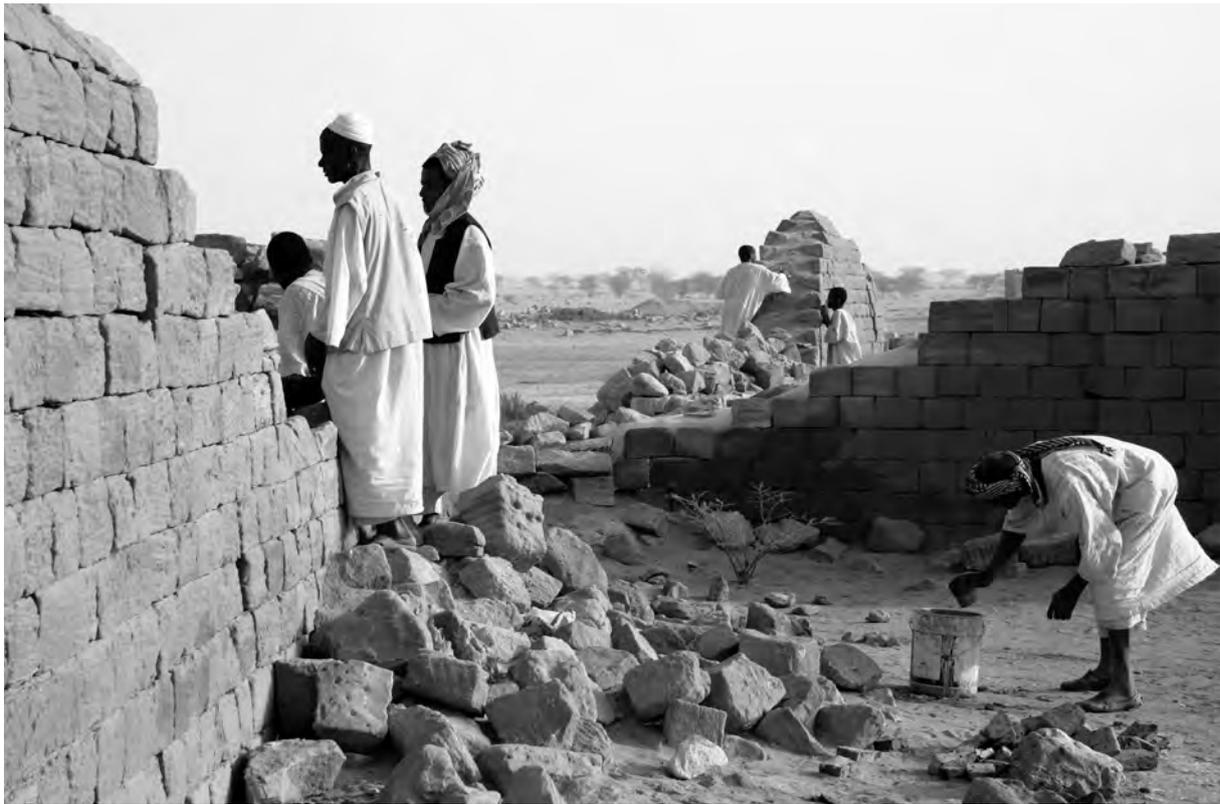
Fig. 22: Covering open wall tops with a lime mortar capping in Complex 500; in the centre and the background walls after treatment (photo: Claudia Näser)

In spring 2015, lime mortar capping concentrated on Complexes 200 and 500 of the Great Enclosure i.e. the buildings and courtyards surrounding Temple 200 and north of the Central Terrace (figs. 8, 22). Altogether, 190m of walls received a cover. Photographs were taken of all walls prior to their treatment in order to facilitate condition assessments and future monitoring.

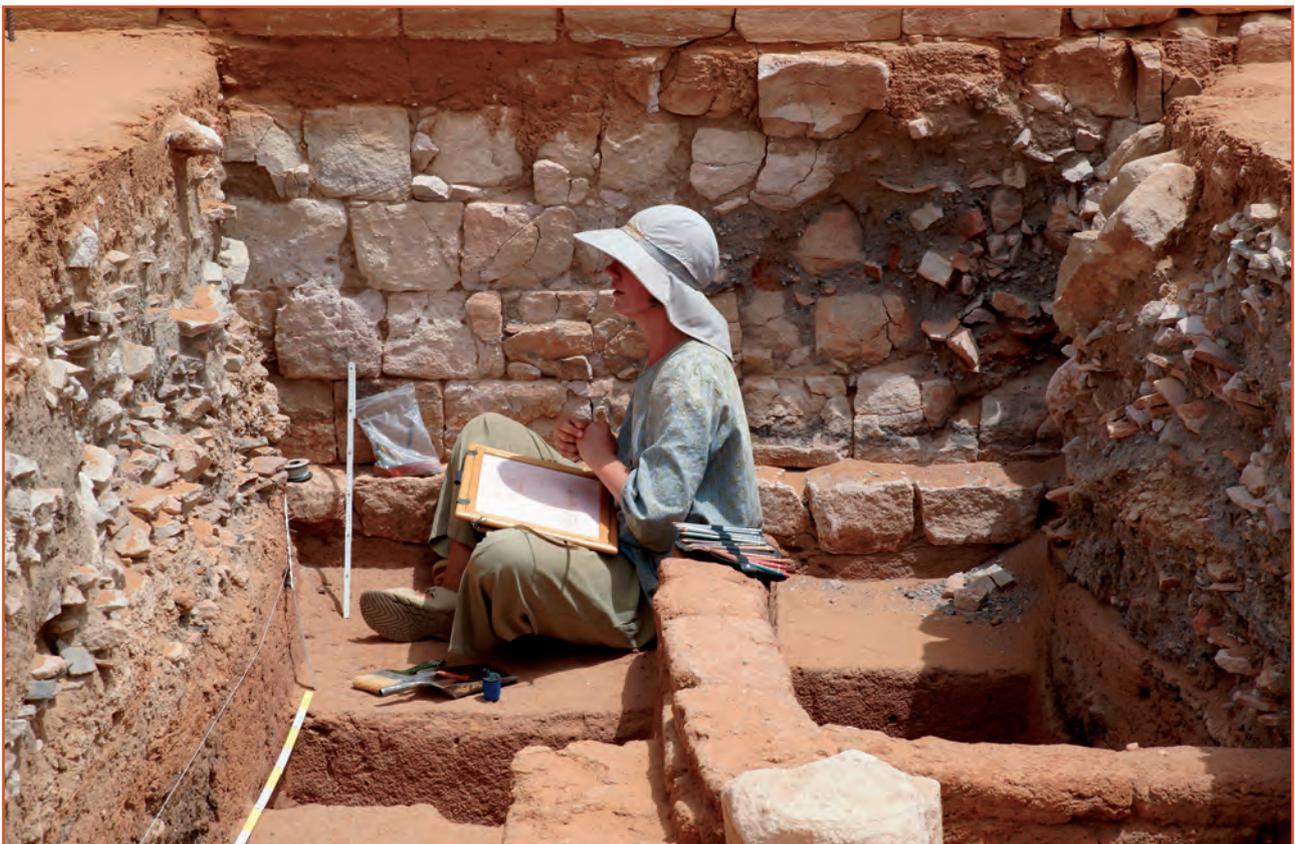
Colour fig. 4: Southern face of wall 224/N in trench 224.15 (photo: Andrea Methner)

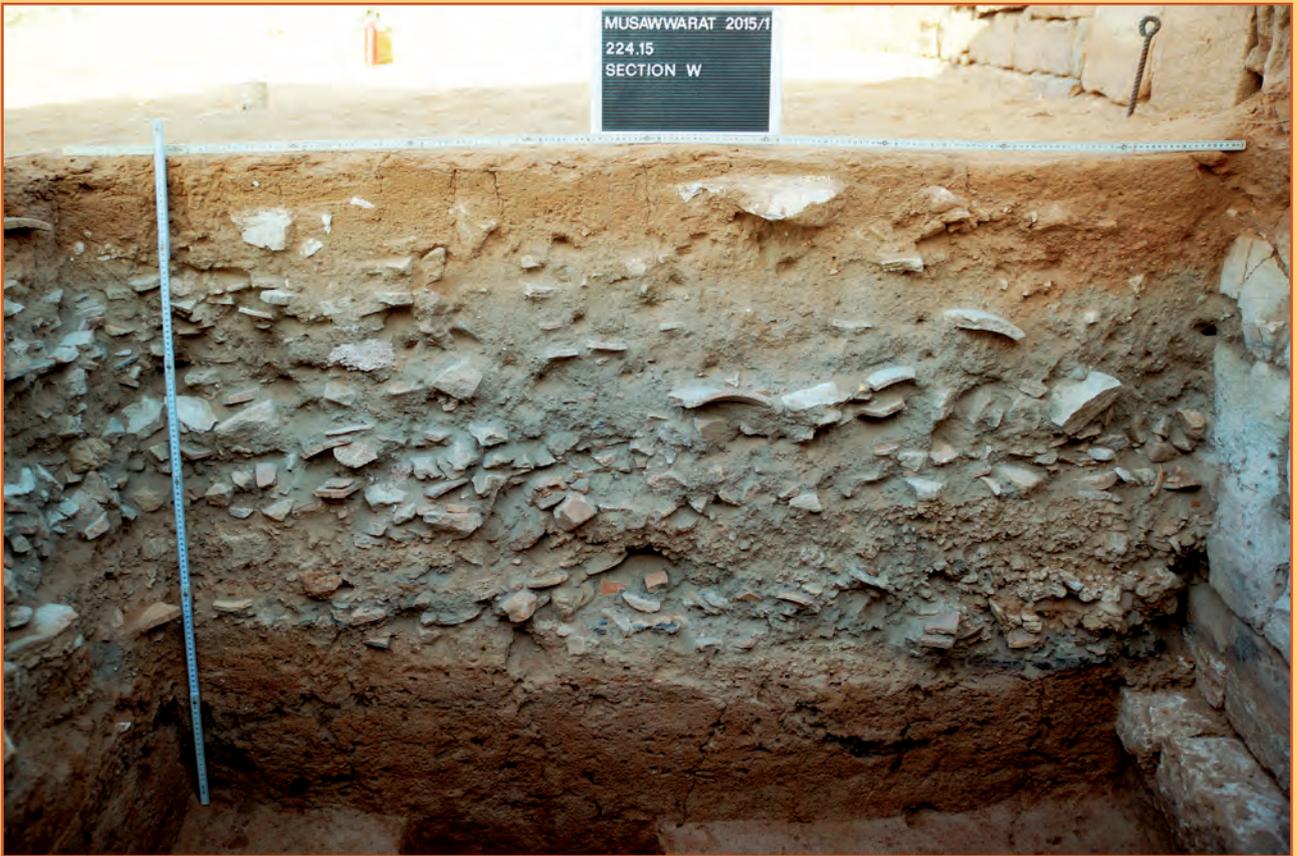
Colour fig. 5: Northern part of the western section of trench 224.15 (photo: Claudia Näser)

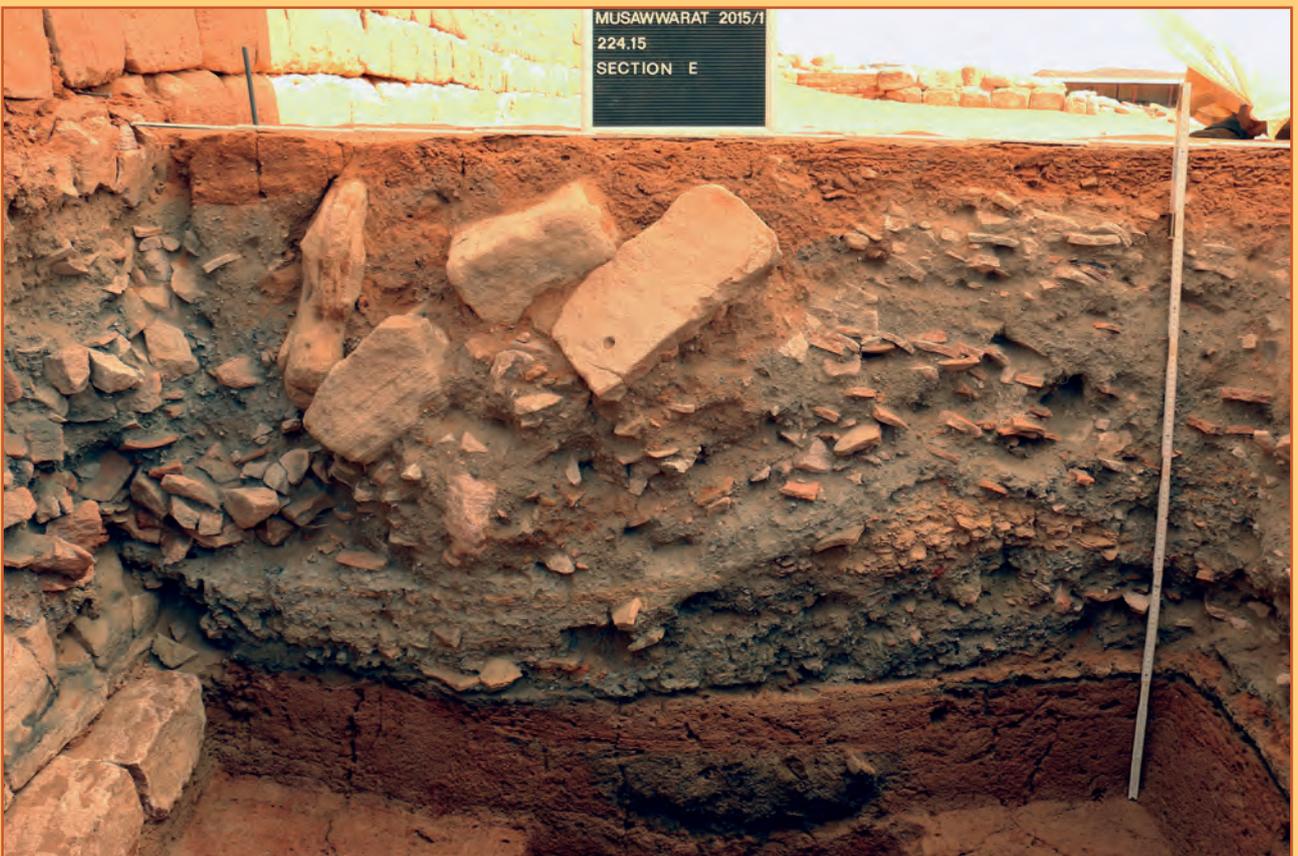
Colour fig. 6: Northern part of the eastern section of trench 224.15 (photo: Claudia Näser)
